MARITIME REGULATIONS CASE STUDY

TANKER ACCIDENTS AND THE AVOIDANCE OF POLLUTION

Tankers Grounding: “Sea Empress”, “Borga”, “Propontis”

Legal Regime, Accident Conditions/Reasons, Consequences, Lessons Taught

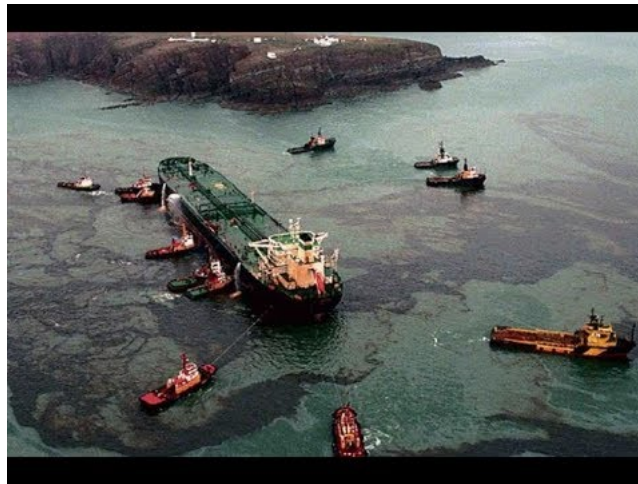
Sea Empress Tanker Accident, www.walesonline.co.uk.

On February 15th 1996 at 20:00, the Liberian registered single hull (with some side ballast tanks but no double bottom tanks) tanker Sea Empress struck a rock at the entrance to Milford Haven. There was a pilot on board who joined the vessel at 19:30. Four cargo tanks and several ballast tanks suffered damage from this grounding and significant amounts of oil started spilling (CEDRE, 2011).

Young's report (Young, 1997) made for the Marine Accident Investigation Branch (MAIB) of the British government, indicated that the cause of the initial grounding was due to pilot error. It was further noted that a lack of tugs of the appropriate power and manoeuvrability combined with bad weather conditions and lack of understanding of the area's tidal currents led to delay and further spilling during the salvage operation. It is noteworthy to mention that the initial grounding led to 2,500 tonnes of oil spilled whereas 69,300 were spilled during the salvage operation!

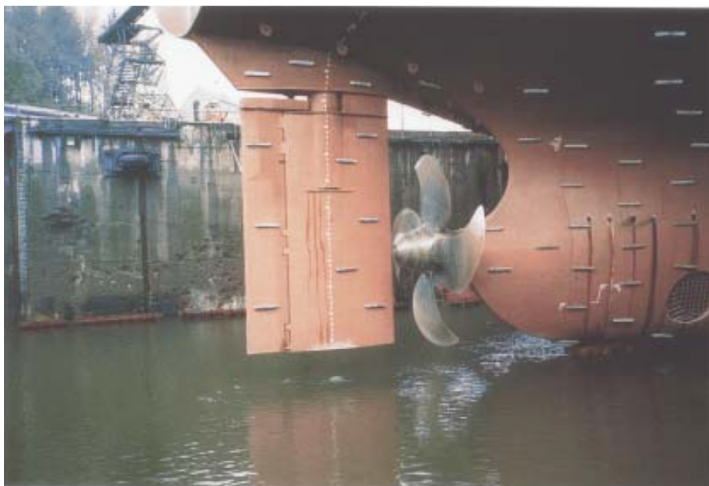
Figure 1.7 General view of the ruder and propeller of Borga from the starboard side

The incident was caused by a failure to compensate fast enough for the vessel's turn rate to port by applying sufficient starboard helm following an alternation of her course (MAIB Report, 1996).

Although the helmsman's port helm application may have been reasonable in the circumstances it was Borga's manoeuvring characteristics that did not allow the shortest delay in removing the port helm. It was noted that this characteristic was not noted on the Pilot card (MAIB Report, 1996).

Grounding damage was restricted to the front end of the tanker (Figure 1.)

1. The vessel's design (segregated ballast and double bottom) was possibly a contributing factor to the avoidance of pollution in the area where the Sea Empress tragedy resulted in 73,000 tonnes of oil spilled.
2. The MAIB Report suggested an amendment to SOLAS 1974 Convention and the 1978 Protocol, Chapter II-I, Part C, Regulation 29, Paragraph 8, Section 8.4 that it should include a low hydraulic pressure alarm sensor alarm in addition to the requirement for an electrical power supply failure alarm already in set in the Convention. This suggestion was not adopted by IMO though although it has

recently amended Regulation 29 in respect to steering gear and rudder stock as well as auxiliary steering gear (Paragraphs 3 and 4) with Resolution MSC.365(93) adopted on 22nd of May 2014.

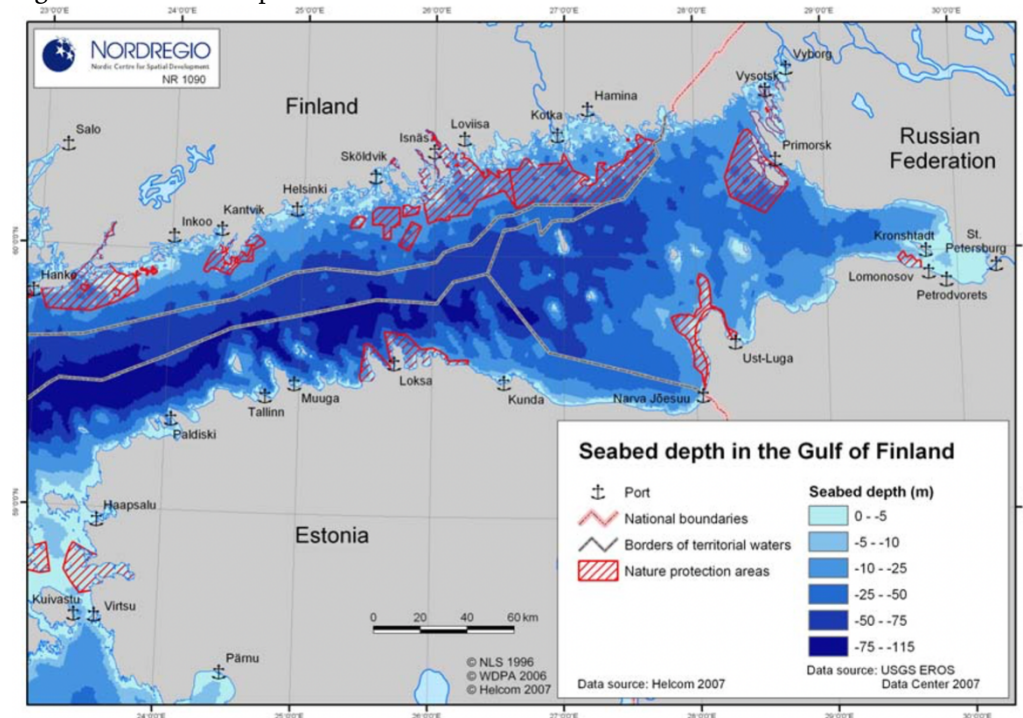
Figure 1.8 Seabed depth in the Gulf of Finland

The vessel was sailing in an area where the deepness of water is less than the deepness of the vessel hence the grounding was inevitable. A combination of the fact that the rock was not high enough to damage the upper part of the double bottom and the fact that the vessel was double hull helped avoid the spill (Luoma, 2009).

It should be noted that the area of the Baltic Sea is shallow and natural cleaning processes are rather slow (Luoma, 2009). An oil spill would thus have devastating effects.
