MARITIME REGULATIONS CASE STUDY

TANKER ACCIDENTS AND THE AVOIDANCE OF POLLUTION

Athens, 2017

Tankers Grounding: “Sea Empress”, “Borga”, “Propontis”

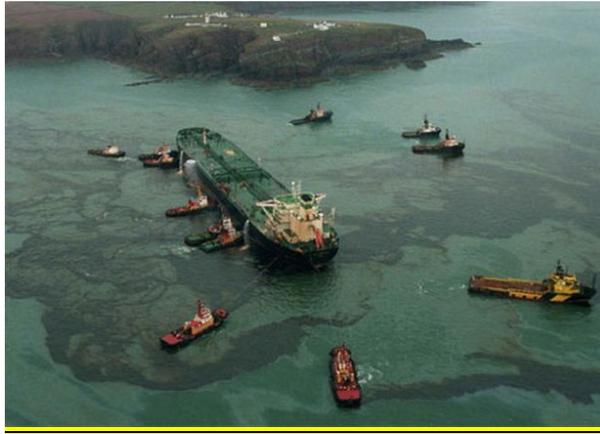
Sea Empress Tanker Accident, www.walesonline.co.uk.

On February 15th 1996 at 20:00, the Liberian registered single hull (with some side ballast tanks but no double bottom tanks) tanker Sea Empress struck a rock at the entrance to Milford Haven. There was a pilot on board who joined the vessel at 19:30. Four cargo tanks and several ballast tanks suffered damage from this grounding and significant amounts of oil started spilling (CEDRE, 2011).

Young's report (Young, 1997) made for the Marine Accident Investigation Branch (MAIB) of the British government, indicated that the cause of the initial grounding was due to pilot error. It was further noted that a lack of tugs of the appropriate power and manoeuvrability combined with bad weather conditions and lack of understanding of the area's tidal currents led to delay and further spilling during the salvage operation. It is noteworthy to mention that the initial grounding led to 2,500 tonnes of oil spilled whereas 69,300 were spilled during the salvage operation!

Since the accident the Milford Haven Pilotage Authority (MHPA) amended the pilotage rules so that two pilots are taken by vessels over 65,000 GT and above.

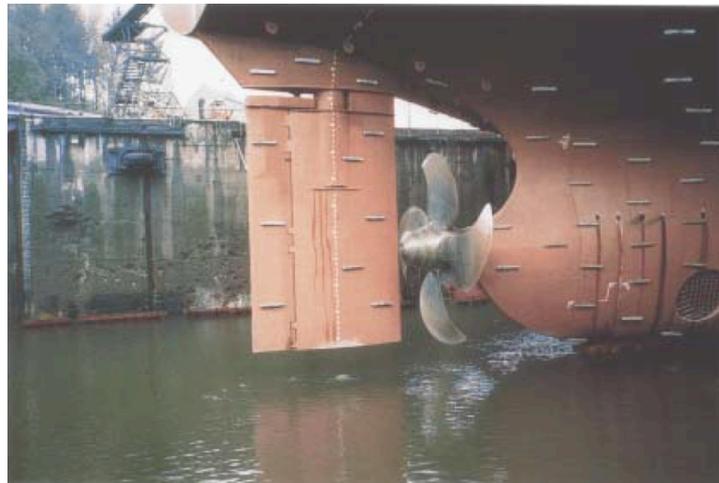
Figure 1.7 General view of the ruder and propeller of Borga from the starboard side

The incident was caused by a failure to compensate fast enough for the vessel's turn rate to port by applying sufficient starboard helm following an alternation of her course (MAIB Report, 1996).

Although the helmsman's port helm application may have been reasonable in the circumstances it was Borga's manoeuvring characteristics that did not allow the shortest delay in removing the port helm. It was noted that this characteristic was not noted on the Pilot card (MAIB Report, 1996).

Grounding damage was restricted to the front end of the tanker (Figure 1.)

1. The vessel's design (segregated ballast and double bottom) was possibly a contributing factor to the avoidance of pollution in the area were the Sea Empress tragedy resulted in 73,000 tonnes of oil spilled.
2. The MAIB Report suggested an amendment to SOLAS 1974 Convention and the 1978 Protocol, Chapter II-I, Part C, Regulation 29, Paragraph 8, Section 8.4 that it should include a low hydraulic pressure alarm sensor alarm in addition to the requirement for an electrical power supply failure alarm already in set in the Convention. This suggestion was not adopted by IMO though although it has

recently amended Regulation 29 in respect to steering gear and rudder stock as well as auxiliary steering gear (Paragraphs 3 and 4) with Resolution MSC.365(93) adopted on 22nd of May 2014.
