MARITIME REGULATIONS CASE STUDY

TANKER ACCIDENTS AND THE AVOIDANCE OF POLLUTION

Athens, 2017

Tankers Grounding: “Sea Empress”, “Borga”, “Propontis”

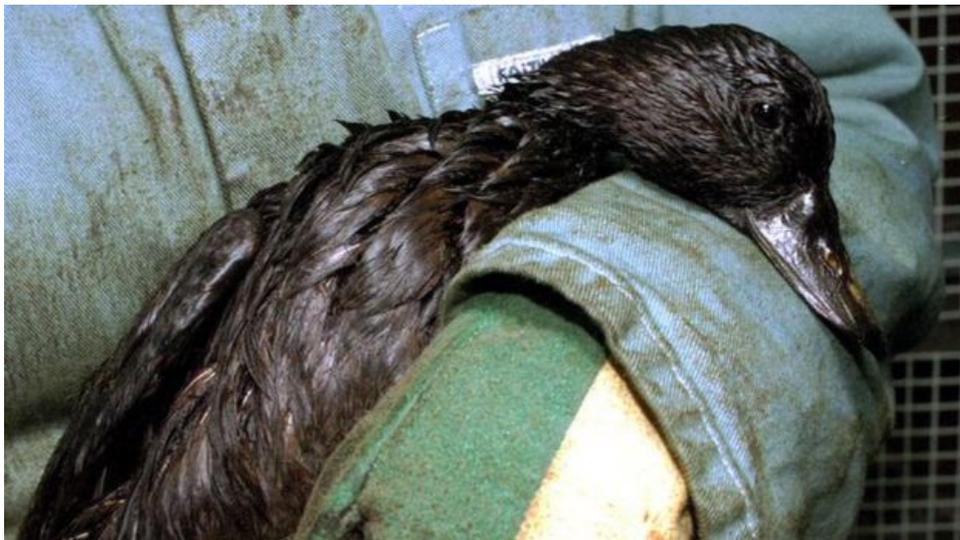
Figure 1.6 Duck rescued from the oil spill

According to the Royal Society for the Protection of Cruelty to Animals (RSPCA) 4,000 birds died and a further 3,600 were taken into care (IOPC Fund, 1996).

Fishing activities were banned in the surrounding area.

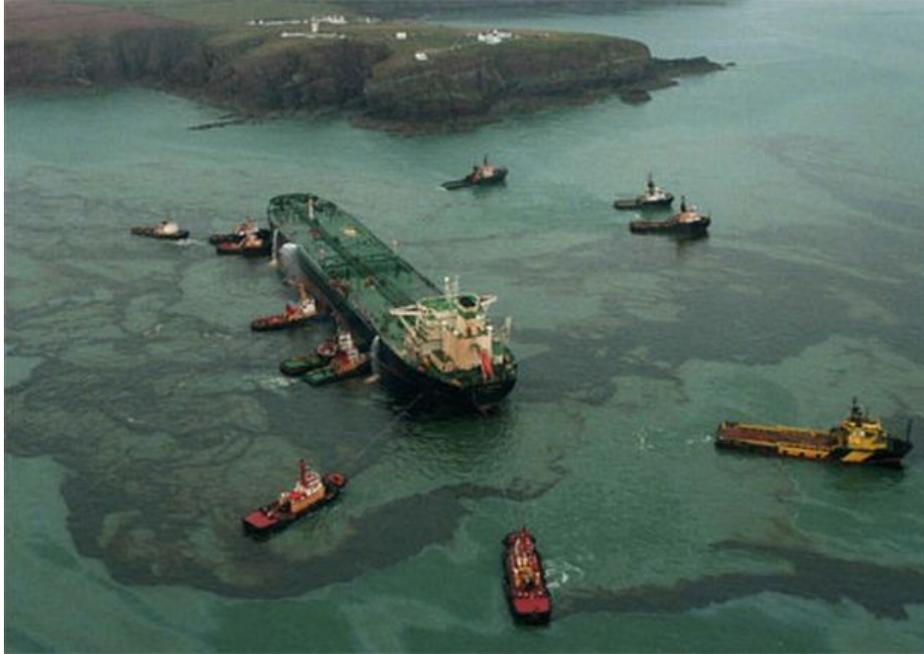
On February 15th 1996 at 20:00, the Liberian registered single hull (with some side ballast tanks but no double bottom tanks) tanker Sea Empress struck a rock at the entrance to Milford Haven. There was a pilot on board who joined the vessel at 19:30. Four cargo tanks and several ballast tanks suffered damage from this grounding and significant amounts of oil started spilling (CEDRE, 2011).

During the next days the vessel was refloated and ran aground several times, causing further damage to more cargo and ballast tanks.

Young's report (Young, 1997) made for the Marine Accident Investigation Branch (MAIB) of the British government, indicated that the cause of the initial grounding was due to pilot error. It was further noted that a lack of tugs of the appropriate power and manoeuvrability combined with bad weather conditions and lack of understanding of the area's tidal currents led to delay and further spilling during the salvage operation. It is noteworthy to mention that the initial grounding led to 2,500 tonnes of oil spilled whereas 69,300 were spilled during the salvage operation!

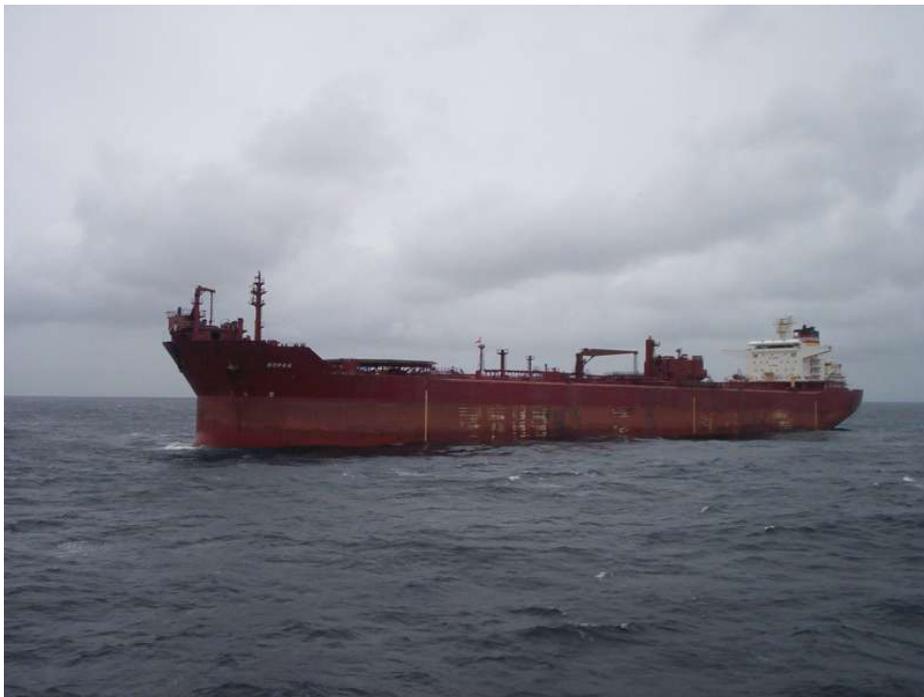
Borga

The weather conditions were clear and good. There was damage to the hull but the vessel, unlike Sea Empress had double bottom tanks (she was not a double hull though).

The incident was caused by a failure to compensate fast enough for the vessel's turn rate to port by applying sufficient starboard helm following an alternation of her course (MAIB Report, 1996).

Although the helmsman's port helm application may have been reasonable in the circumstances it was Borga's manoeuvring characteristics that did not allow the shortest delay in removing the port helm. It was noted that this characteristic was not noted on the Pilot card (MAIB Report, 1996).
